BANDERA ROAD GROUND WATER PLUME SUPERFUND SITE Community Advisory Group Meeting

December 14, 2023

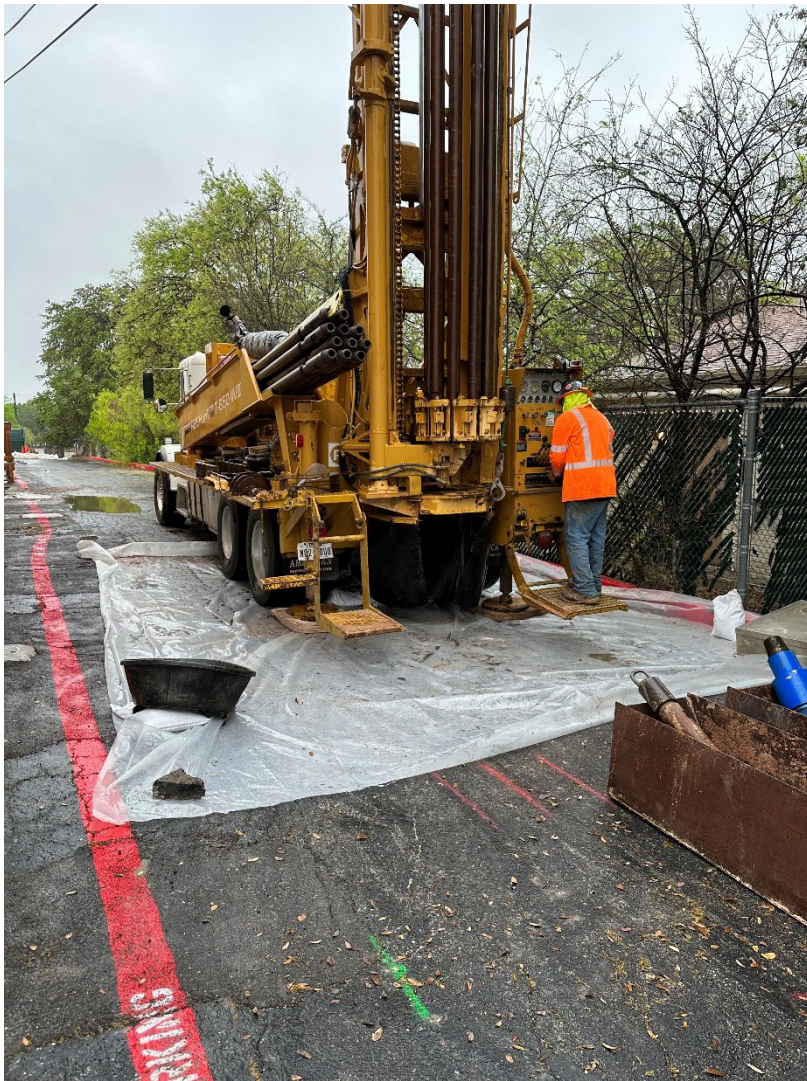
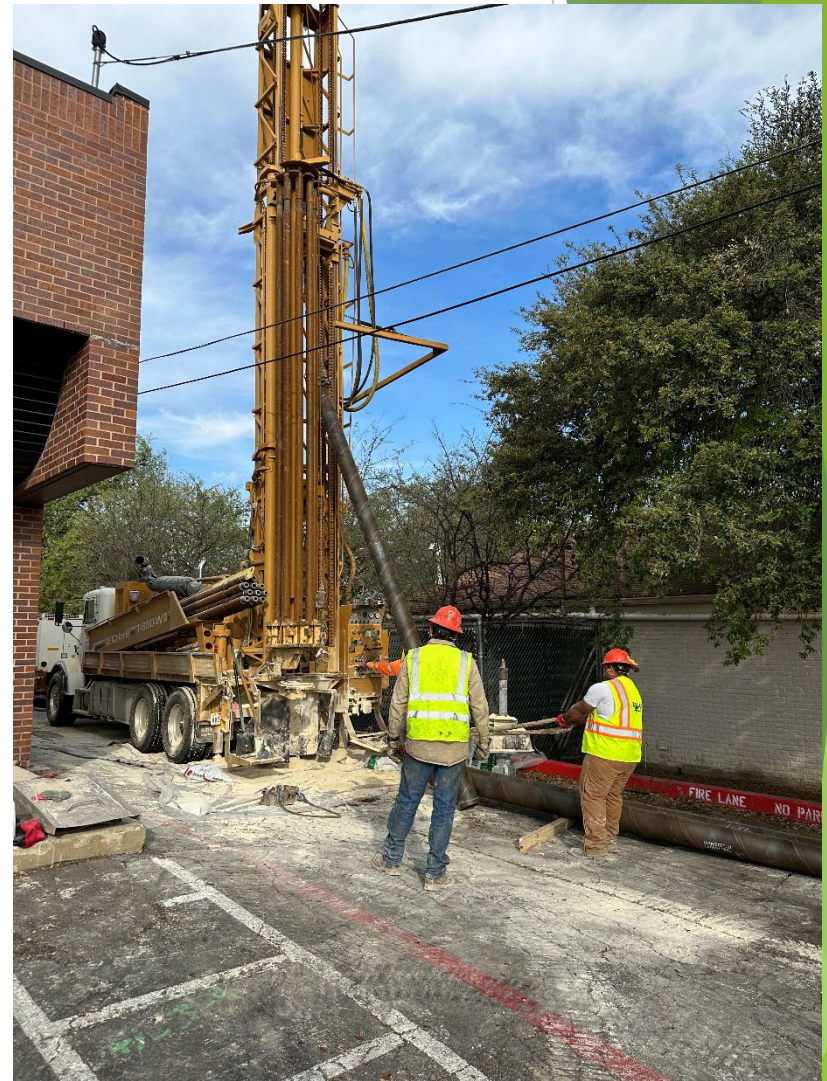
Construction Progress Photos

- Contract Duration: ~6 years (2022 - 2028)
- ISB Construction - Completed
 - Installation of 13 injection wells, well development, baseline sampling, hydraulic testing
- ISB Injections
 - Baseline sampling - Completed
 - Clean water injection testing - Completed
 - First injection in January 2024
 - 2nd injection potentially in 2025 or 2026

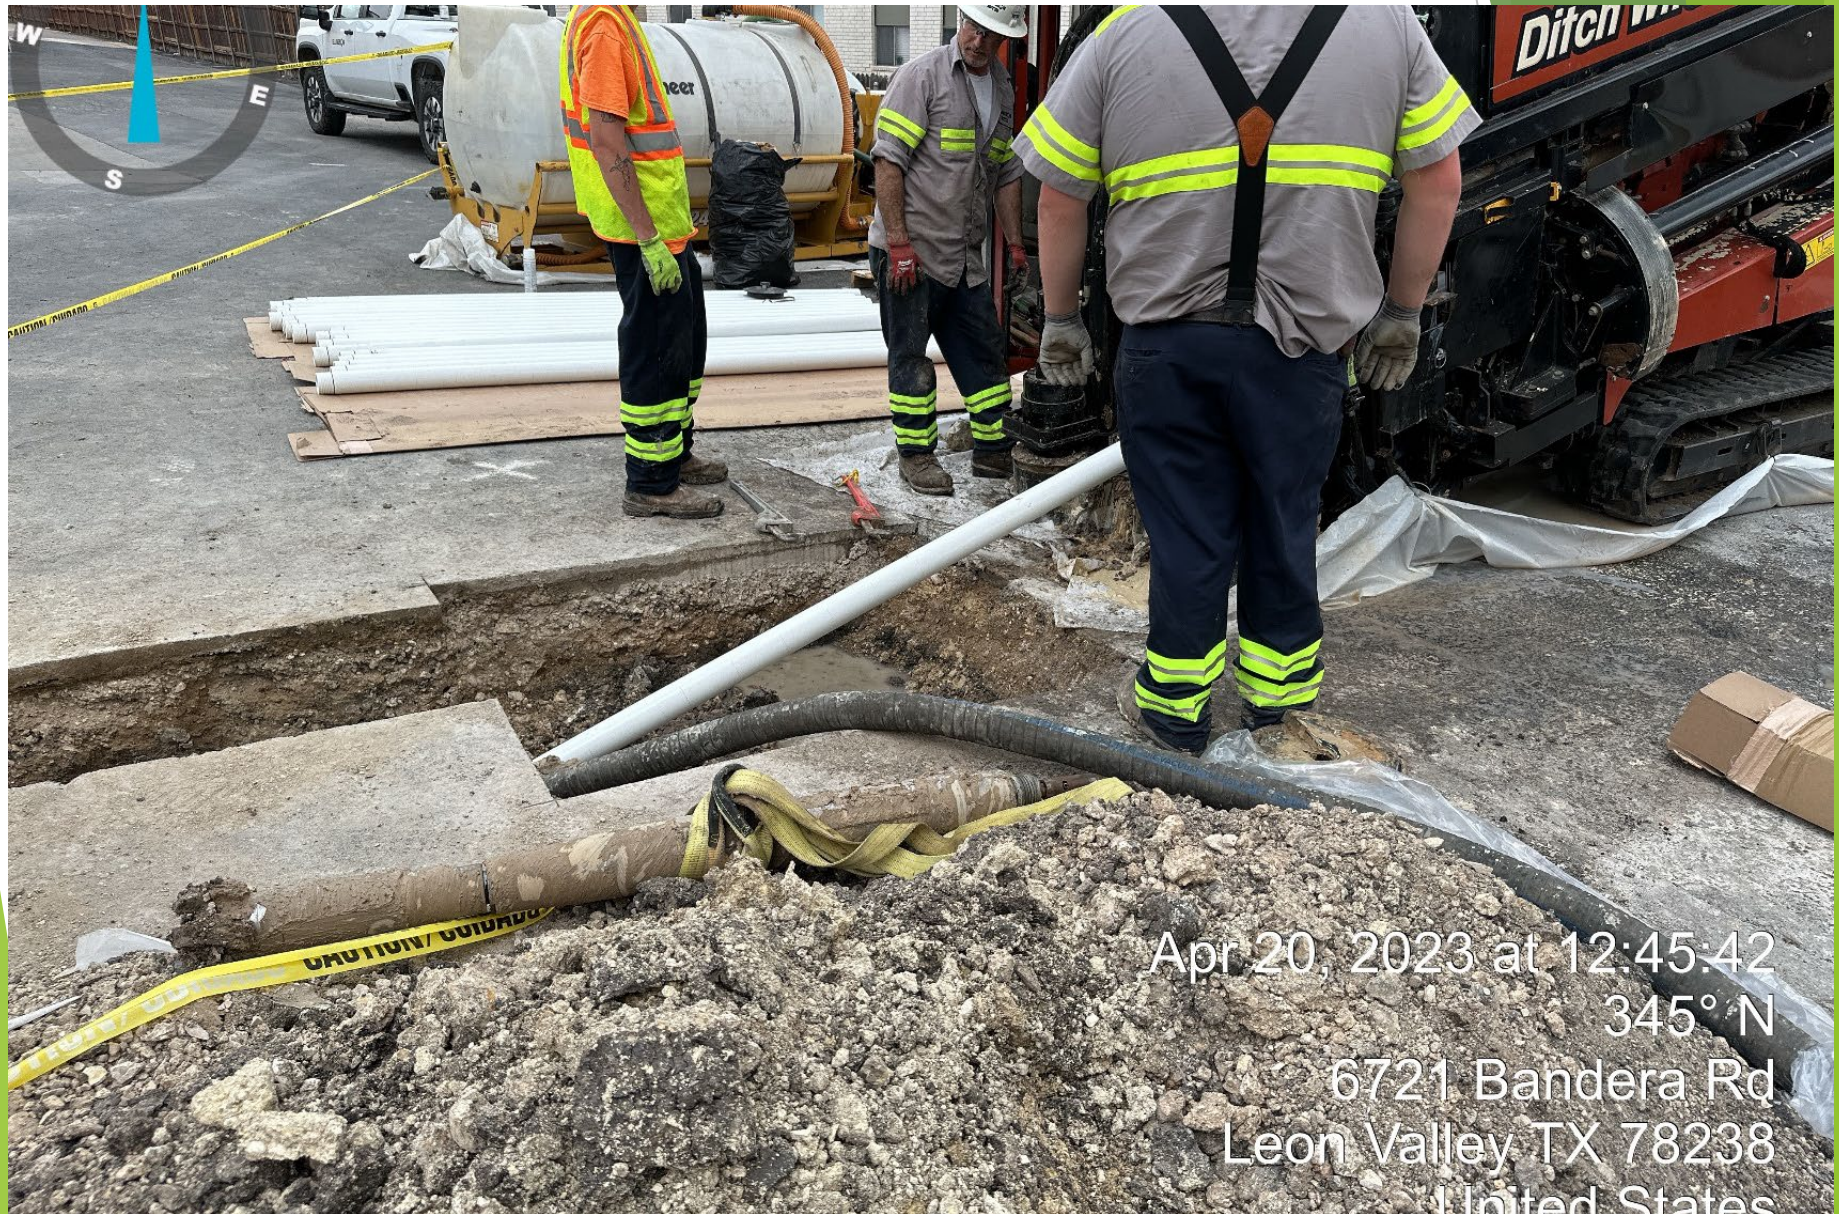
Apr 20, 2023 at 12:45:42
345° N
6721 Bandera Rd
Leon Valley TX 78238
United States

- SVE System Construction
 - Offsite fabrication of SVE system (long lead, critical path) - Completed
 - Installation of horizontal SVE wells - Completed
 - Construction of subsurface piping to connect new and existing SVE wells to the SVE systems - Completed
 - Installation of SVE systems - Completed
 - SVE System Startup Testing - This week
 - Pre-Final site inspection - Next week
 - Reporting
